**Maine Department  
Of  
Environmental Protection**

**DISPENSER  
AND  
SUBMERSIBLE PUMP  
STUDY**

Marcel Moreau Associates

October 2003

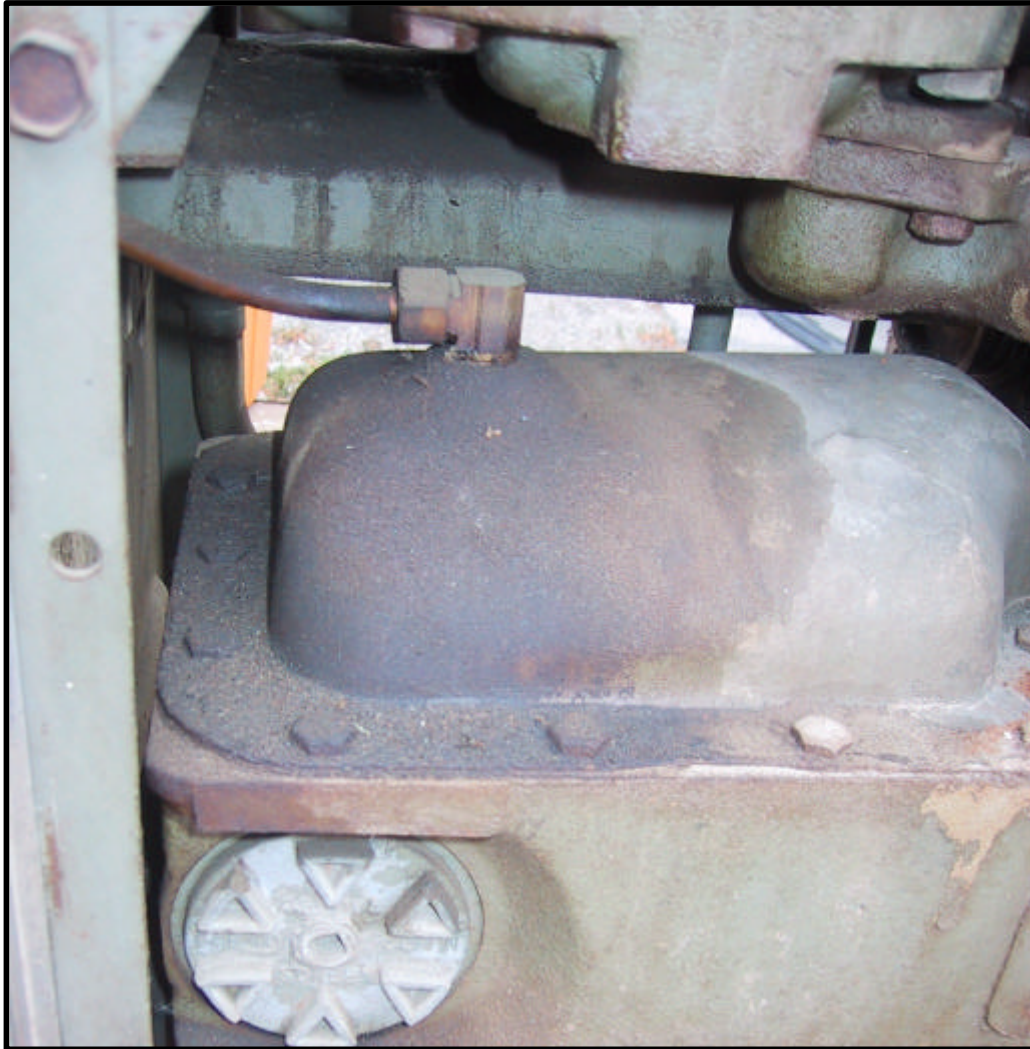
## **What is a Stain?**

Visible discoloration likely due to product that has evaporated in the past.

Dry to the touch.

Product finding paste does not change color when applied.

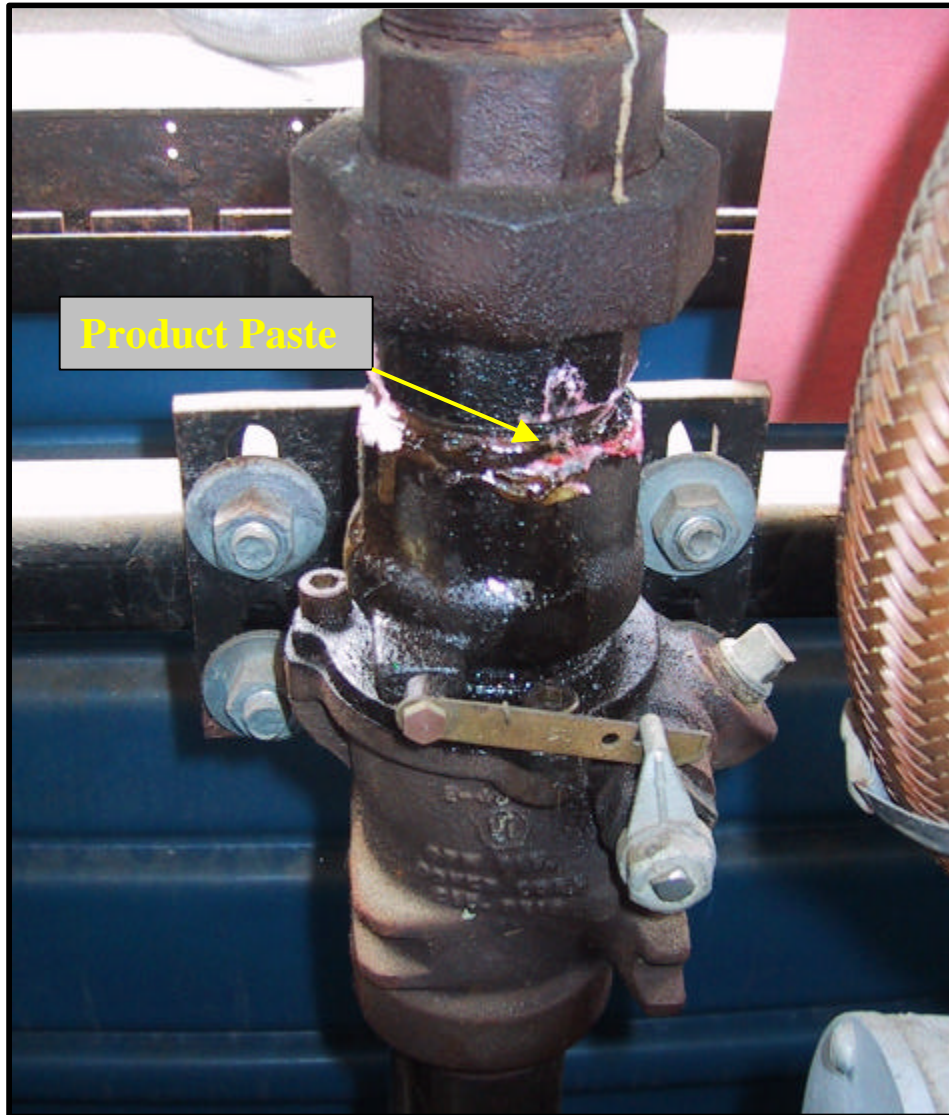
## What is a Weep?

Surface appears wet.

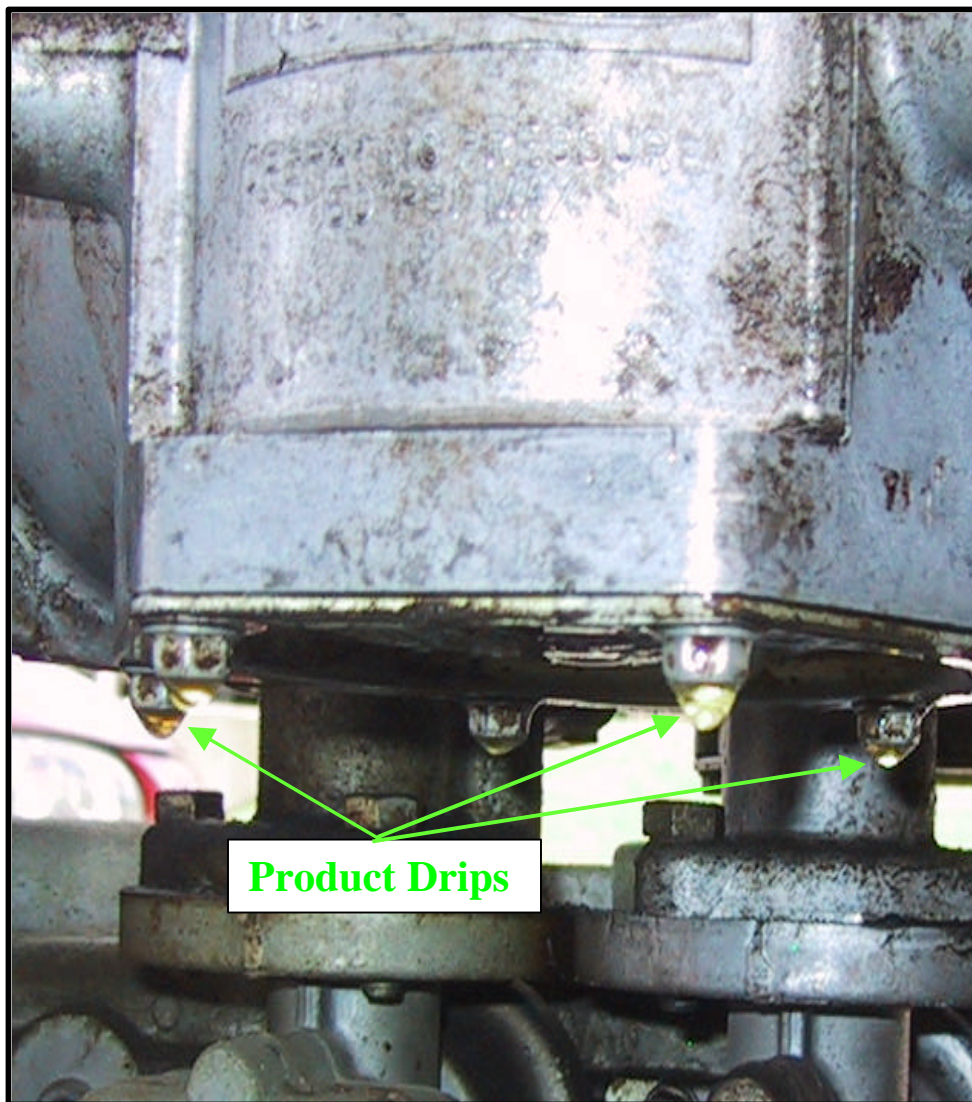
## What is a Drip?

Droplet of product is visible

Droplet falls and another droplet forms when the pump is turned on.
